USATECOM PROJECT NO 1-8-7340-60

PRODUCT IMPROVEMENT TEST OF
T132E1 SNOW PADS FOR
M578 RECOVERY VEHICLE
UNDER ARCTIC WINTER CONDITIONS
FINAL REPORT

SP5 ROBERT A. WAYNE
SCIENTIFIC AND ENGINEERING
APRIL 1969

U. S. ARMY ARCTIC TEST CENTER

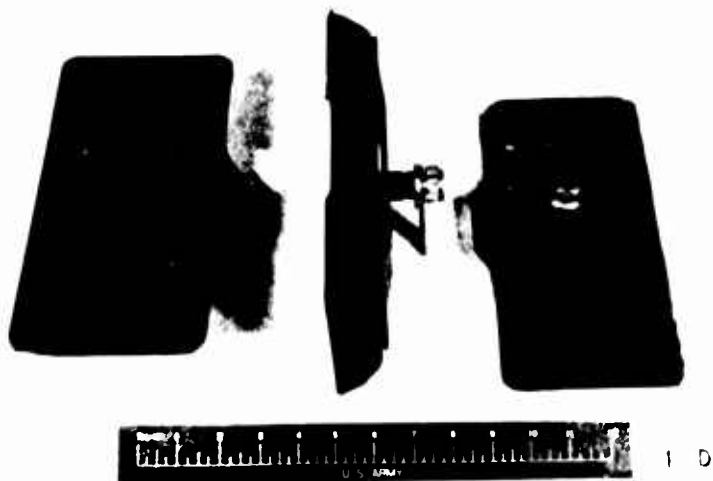
FIGURE 1

THREE VIEW IDENTIFICATION PHOTOGRAPH
OF SPRING LOADED RUBBER TRACK PAD
FOR M578.

Spring Loaded Snow Pads: The spring loaded pads were installed midway through the test season. The pads had been installed for a short time during the FY68 test season, and were slightly worn, but still serviceable and in proper condition for testing.

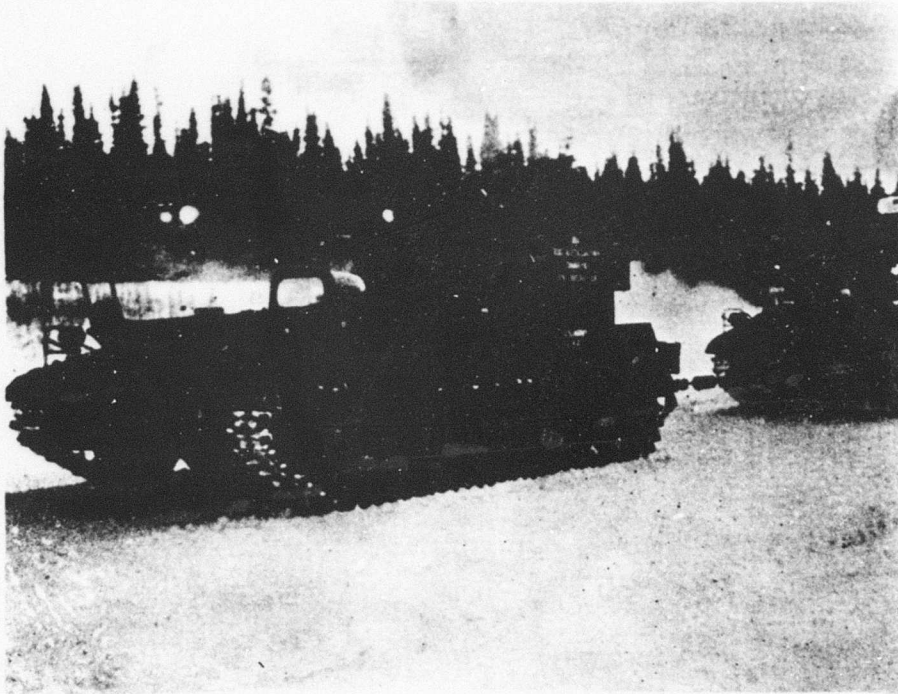
FIGURE 15
M578 TRACK TEST

PHOTOGRAPH SHOWS TESTING AREA FOR HARD-PACKED
SNOW TRIALS. SPROCKET COUNTER CAN BE SEEN ON
THE LEAD VEHICLE; LOAD CELL IS VISIBLE BETWEEN
THE VEHICLES, AND THE FIFTH WHEEL IS MOUNTED AT
THE REAR OF THE LOAD VEHICLE.
